Re: Notice of Violation  
MZX Tech LLC  
Southaven, Desoto County, Mississippi  
GP-Construction Coverage No. MSR109658

## MEMO

DATE: 7/31/2026  
RE: MZX Tech LLC west parcel-Stormwater-Desoto

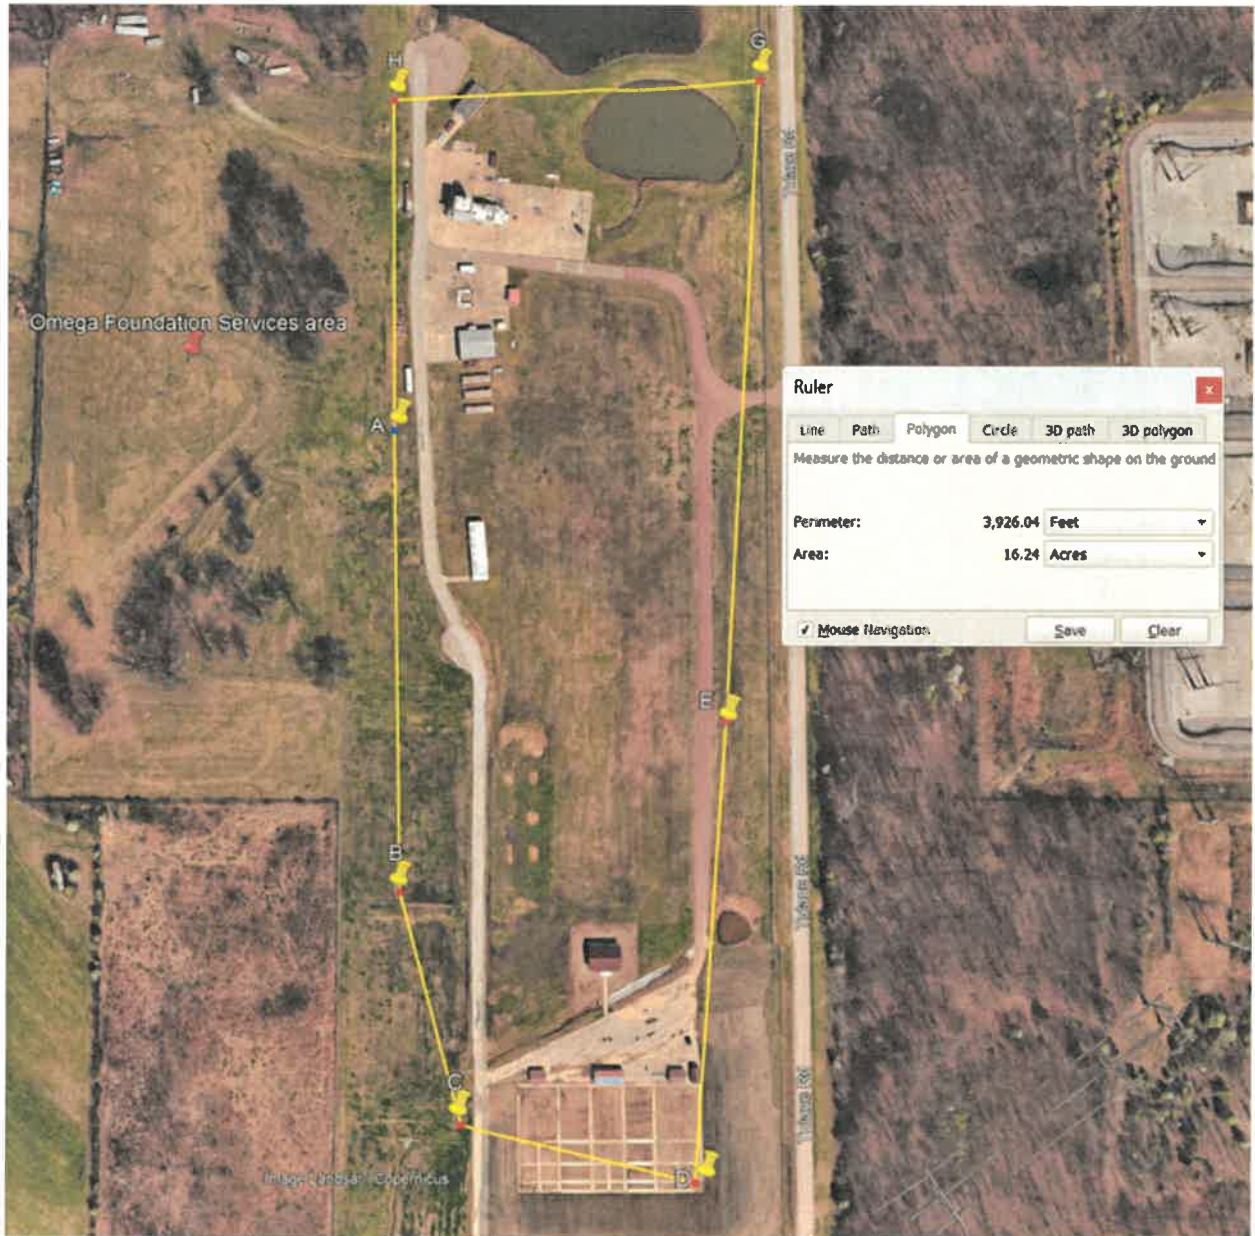
The Omega Foundation Services facility was in use prior to January 2026; construction at the former training facility began sometime after imagery collection but well before our inspection date. Mapping the coordinates we collected onsite shows that more than 16 acres have been disturbed by construction activities on the former Southaven Municipal Training Facility site, plus the area in use by Omega Foundation Services. It is my understanding that these areas do not currently have LCSWGP coverage. Furthermore, no steps have been taken to prevent impacts to existing storm water infrastructure at the site. Fugitive dust emissions from the main section are also a problem; I did see a water truck on site but it was being used to control dust from foundation demolition. No other dust control efforts were observed.

Disturbed perimeter mapped at former Southaven Municipal Training Facility.

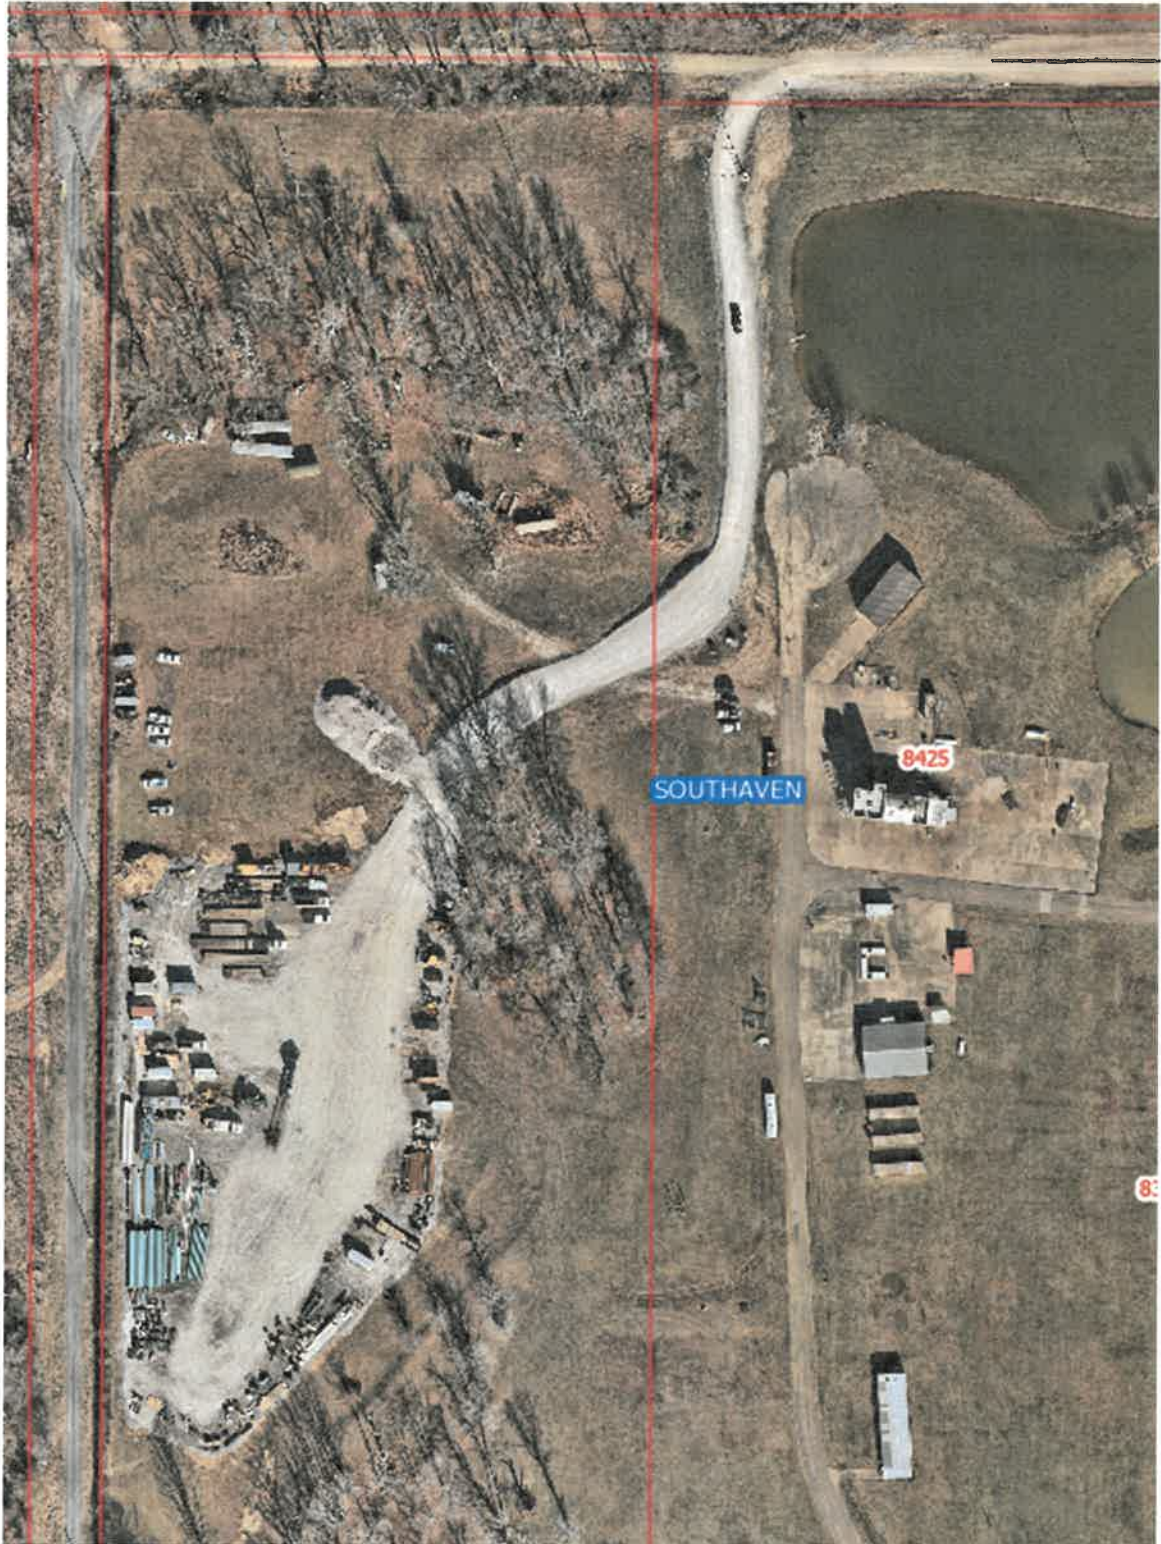
Desoto County has aerial photography taken in January 2026. This imagery shows that the Omega Foundation Services gravel parking area and gravel access road were in place prior to imaging. Several Omega Foundation Services trucks were observed at the MZX generating site in September 2025 during the MMSI inspection. Conversely, there is no sign of

Desoto County January 2026 aerial maps show the area impacted by Omega Foundation Services activities. Note remaining structures on Southaven Municipal Training Facility.

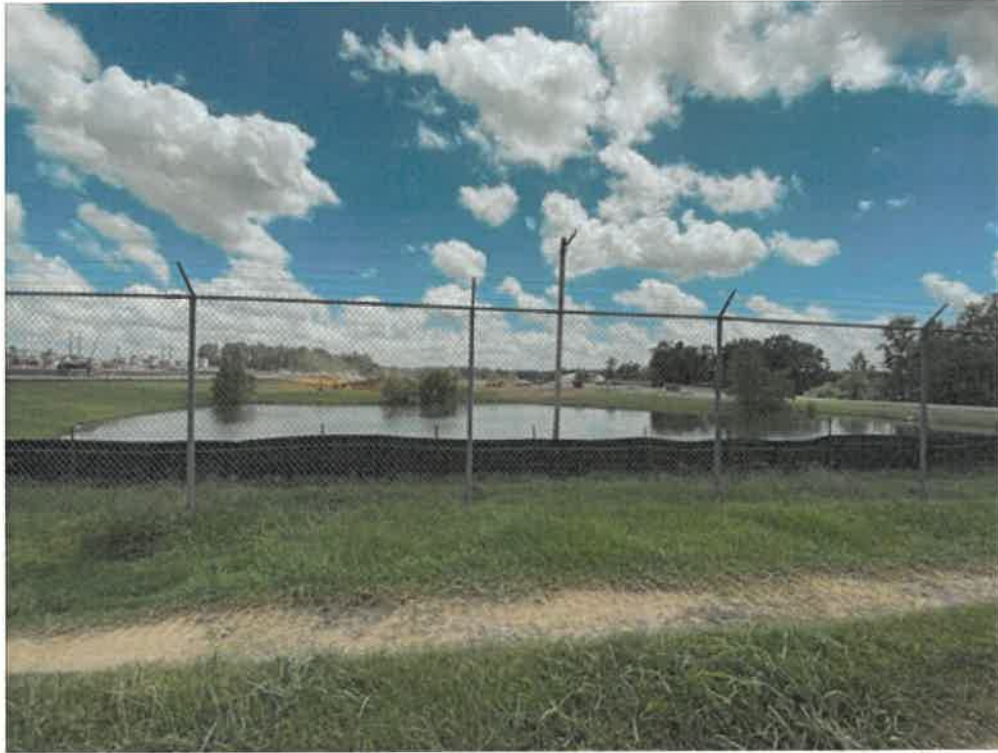
Heavy construction work was underway at the north and south end of the site when we arrived. There was a row of silt fence around the exterior perimeter (Photo 1), but no protections were noted around internal storm drains (Photo 2) or the drainage ditch (Photos 3-4) that runs southwest across the southern end of the property.

Photo 1-Looking south from Stanton; site has chain link fencing and a run of silt fence around the perimeter. The fencing did not appear to be recently installed. Northernmost pond in foreground.

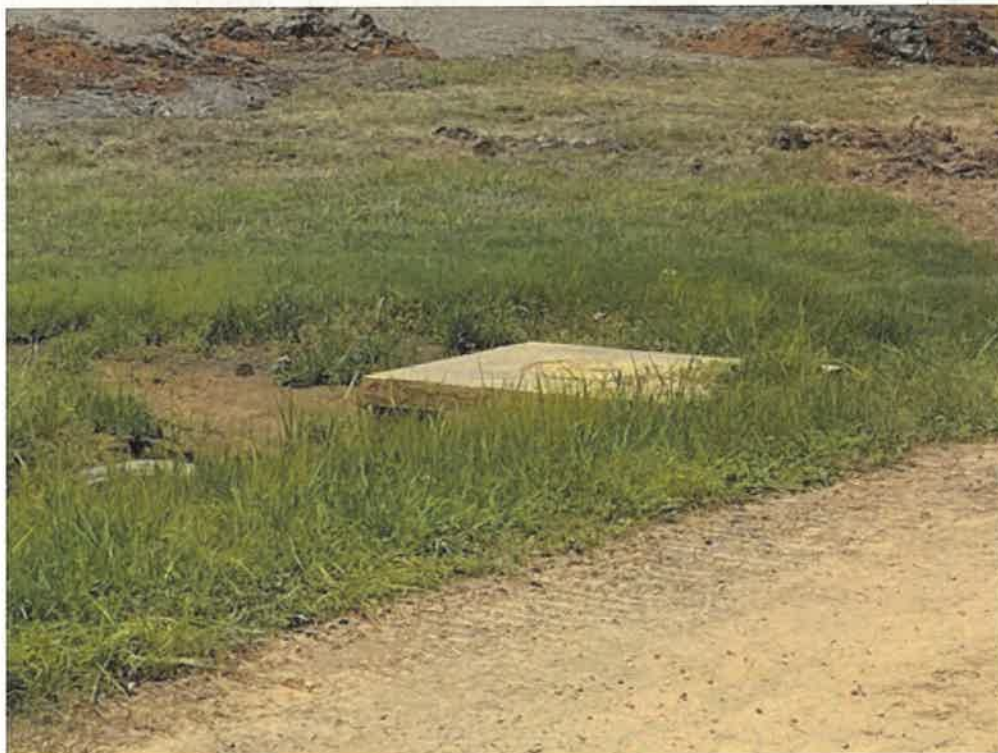
Photo 2-Unprotected storm drain; this was typical for other drains seen inside the fence.

We discussed the need to keep storm water controls maintained since Horn Lake Creek was nearby. I asked Mr. White to install and maintain protections at the existing storm water inlets and drainages on site, as well as downhill of the sludge dewatering areas. I deferred his questions about rerouting an existing utility line to MDEQ main office staff and local officials.

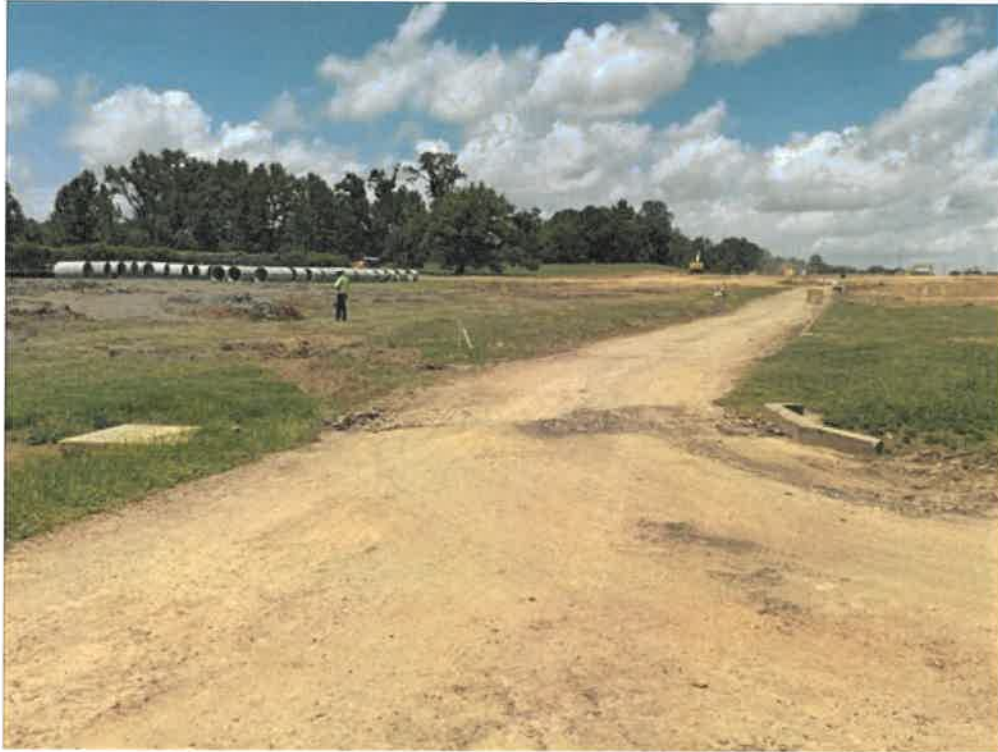
Photo 3-existing tributary across south part of property looking north; no controls along stream or at inlet.

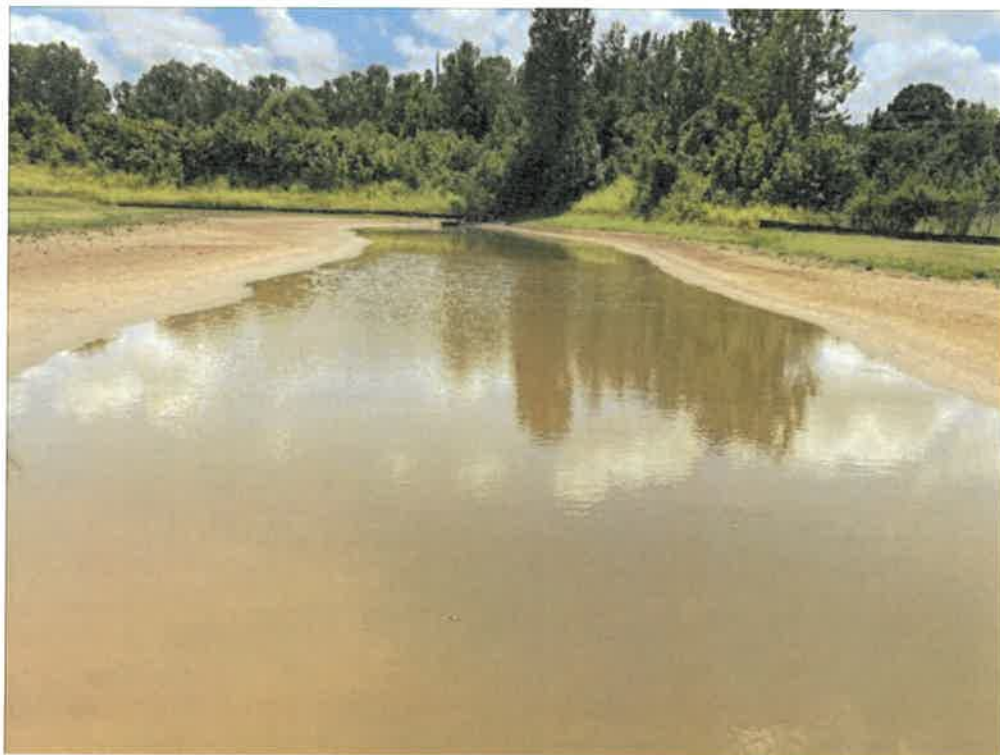
Photo 4-Looking south at last run of ditch flowing to Horn Lake Creek. Note lack of controls beyond perimeter silt fence.

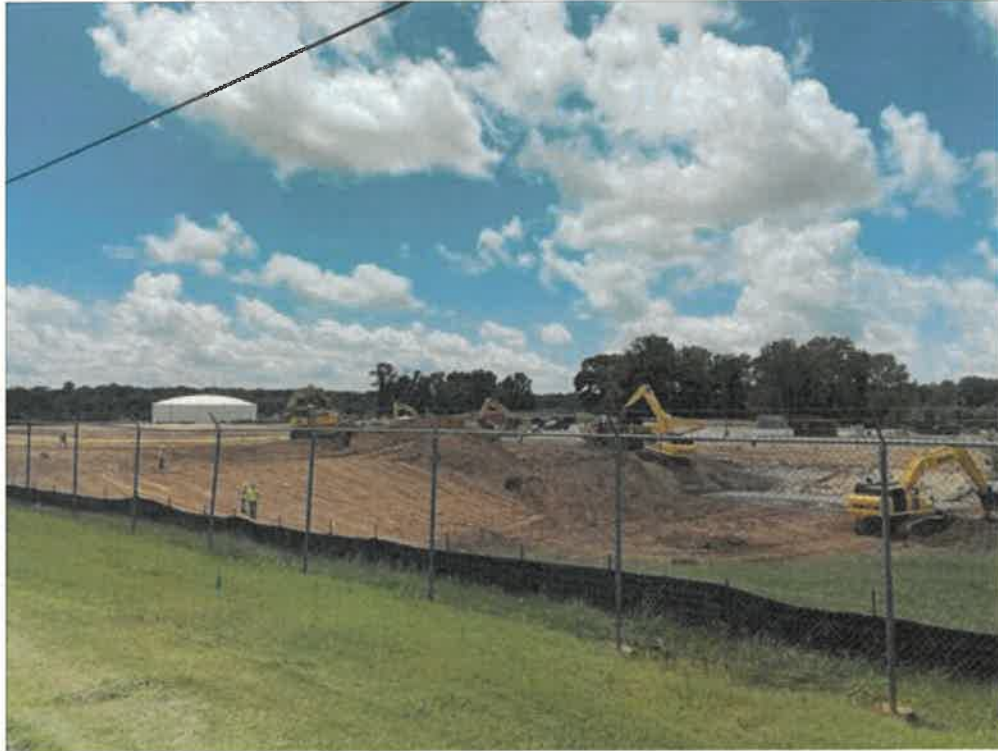
Workers were excavating the smaller of the two existing ponds at the north end of the lot. (Photos 5-6) The pond bottom sediment was being hauled to the southwest part of the lot, where it was dumped just uphill from the lower section of the ditch (Photo 7). These bottoms had a very bad odor that was not detected offsite.

Photo 5-Earthwork going on around small pond.

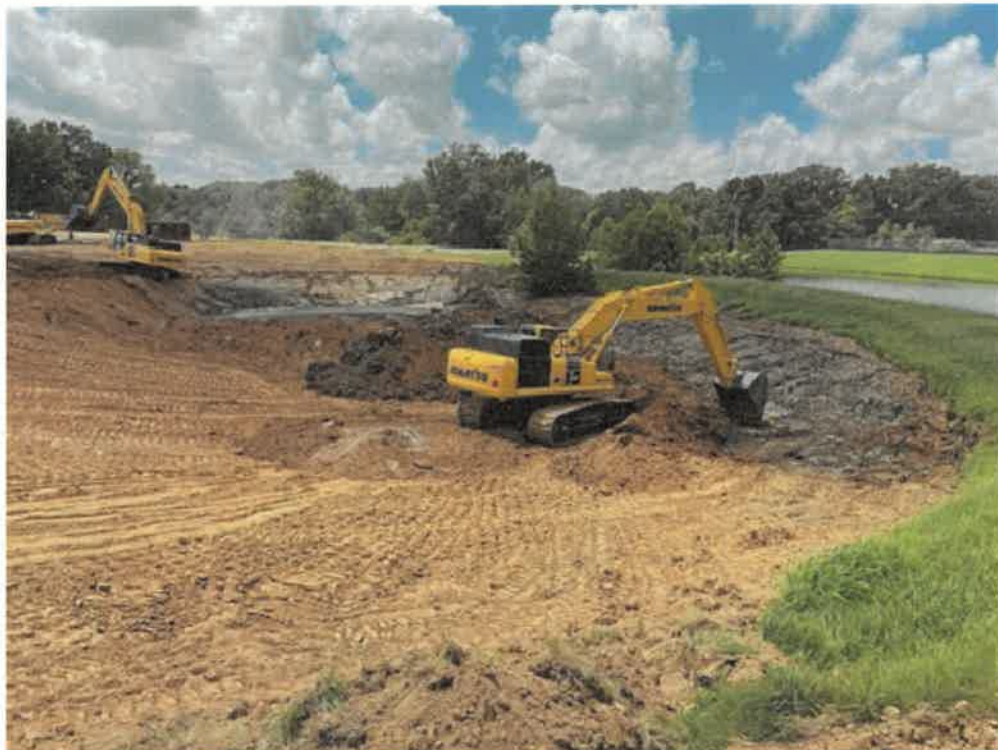
Photo 6-Closer view of smaller north pond work.

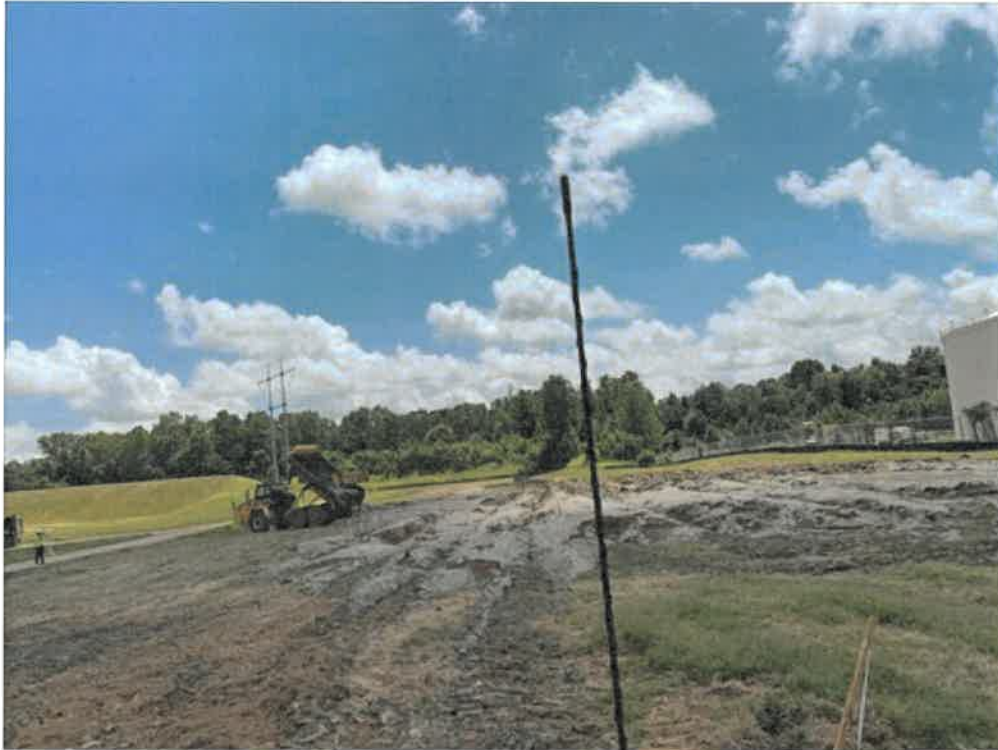
Photo 7-View looking south at pond bottoms being dumped in dewatering area. West end of gun range berm visible in rear left; Horn Lake Sewer tank on right. This is just north/uphill of drainage in Photo 4.

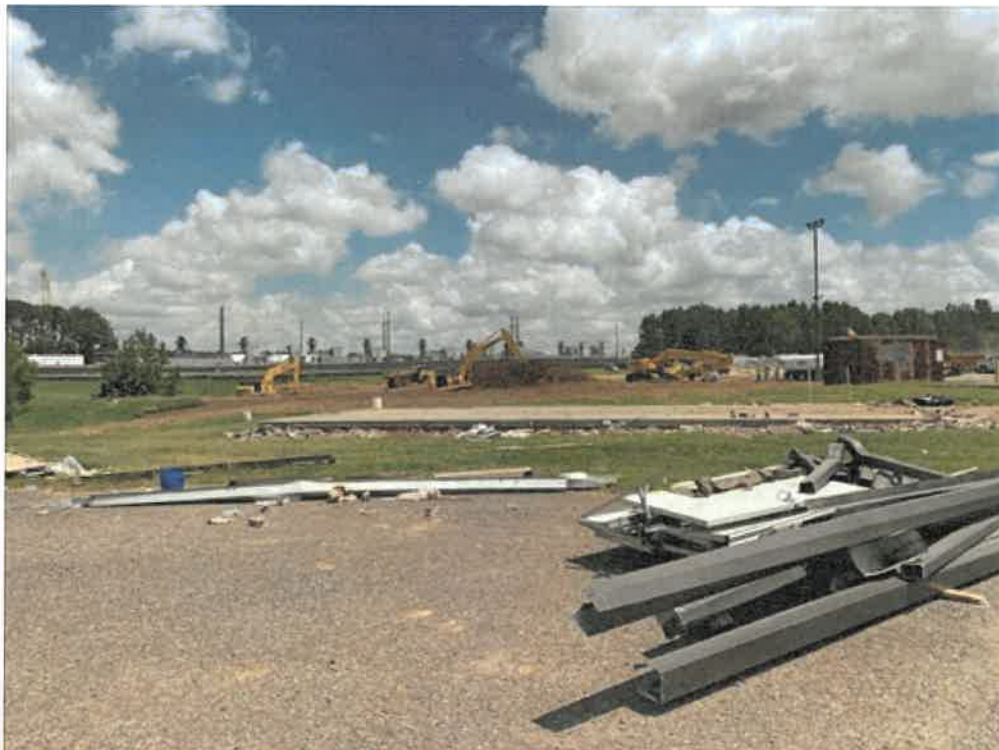
Other workers were breaking up concrete foundations from demolished buildings. Some solid waste and scrap metal from the buildings was still on site. (Photos 8-9). Further south crews were taking down the berm around the shooting range (Photos 10-11). Equipment operators were also working in an area just west of the main stretch (Photo 12). Due to the heavy machinery traffic, we did not enter this area to collect GPS coordinates. This area is undergoing land disturbance as part of this project but is not reflected on the map of disturbed areas or included in the disturbed area calculations for this reason. Much of the site has been disturbed, with no

Photo 8-Remaining scrap and waste from recently-demolished buildings; looking east.

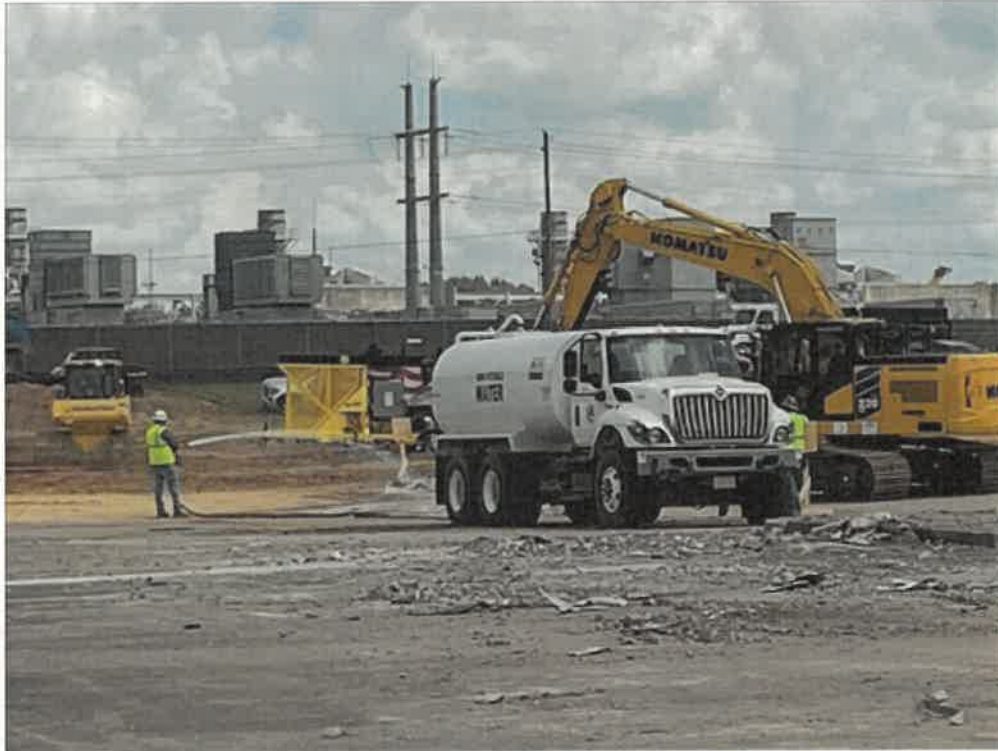
Photo 9-The only water truck observed in use at the site was wetting down concrete for demolition.

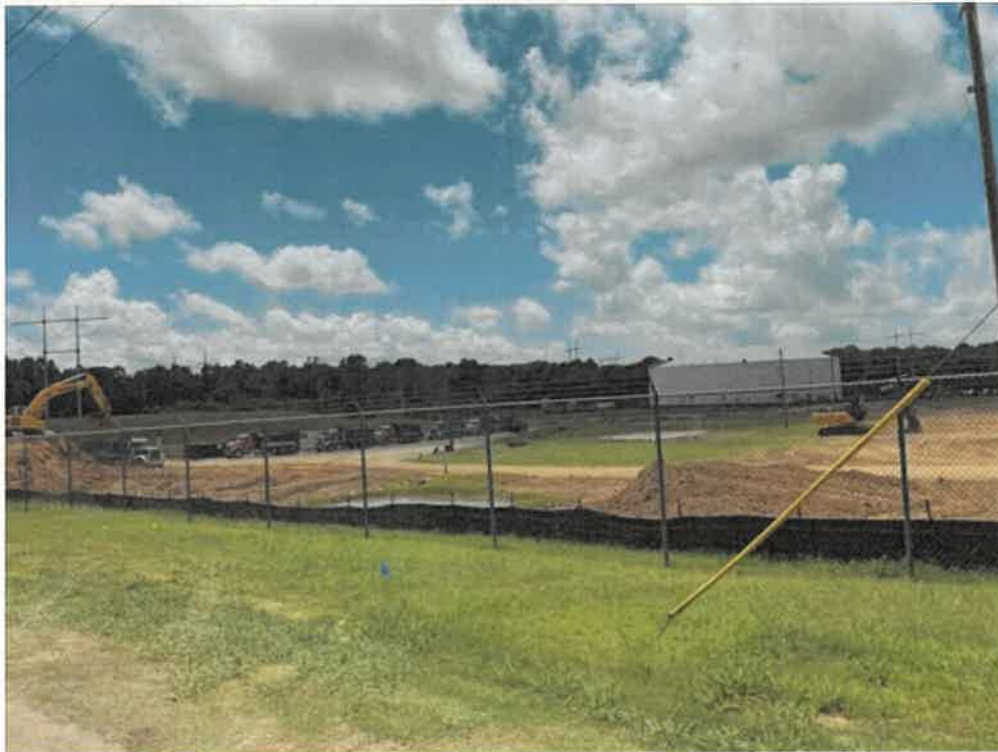
Photo 10-Dump trucks lined up to haul away sections of the gun range berm.

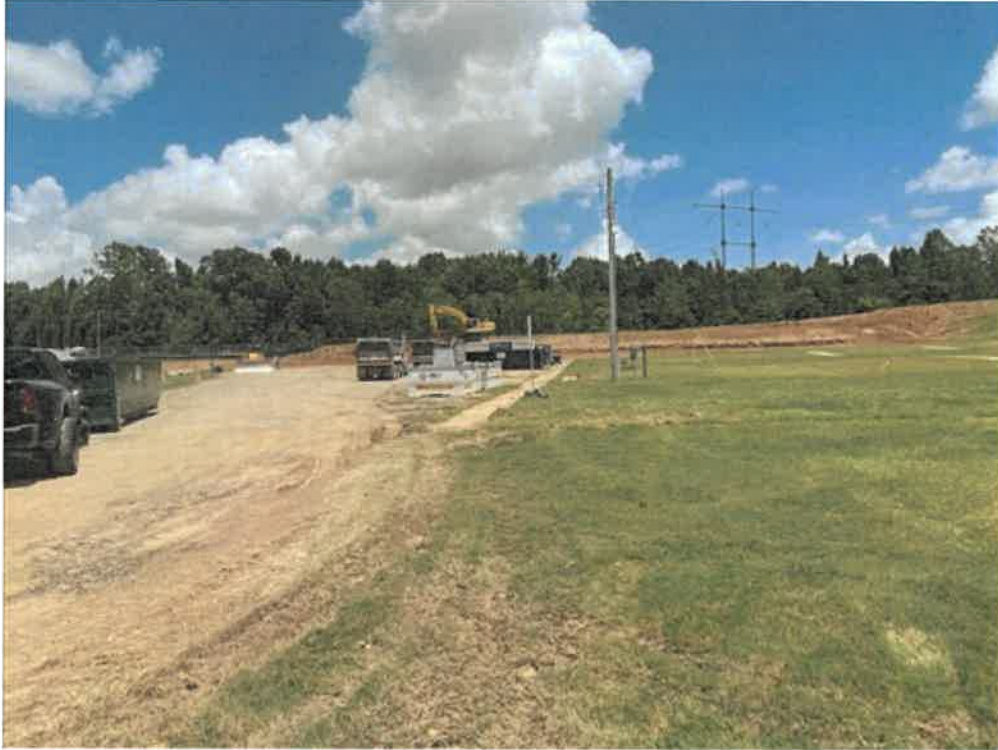
Photo 11-Another view of berm removal.

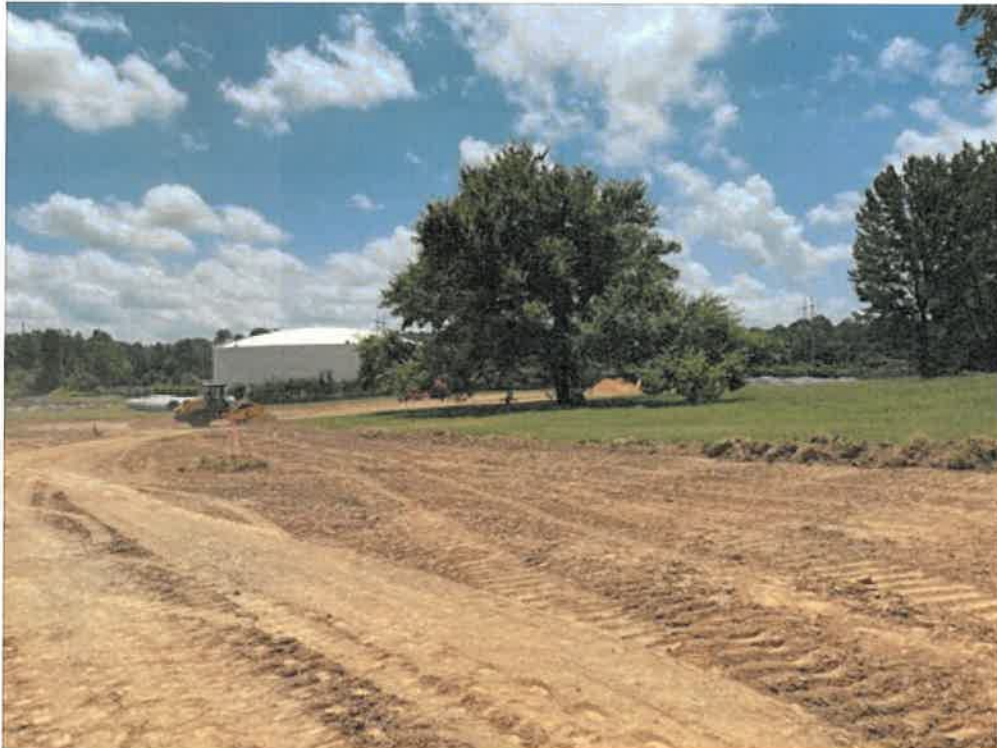
Photo 12-Crews were pushing and compacting this area west of the main section; this area is not included in the disturbed area calculations.

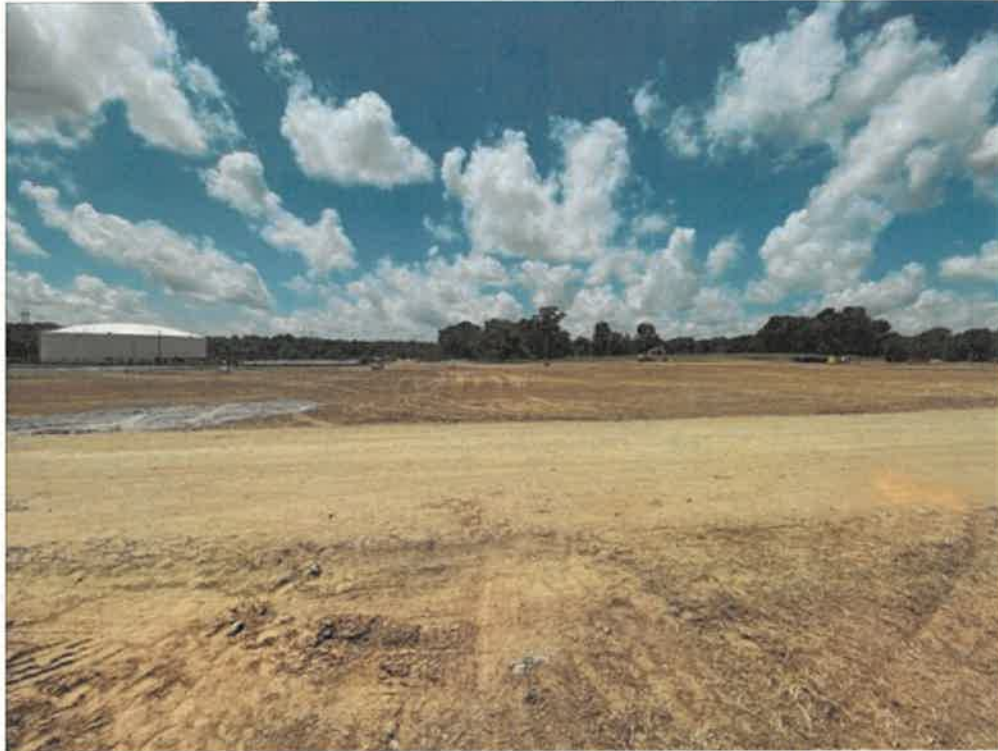
vegetative cover in the middle area of the site (Photo 13). Soil/aggregate stockpiles around the site did not have silt fence around them (Photo 14). We were soon joined by Mike Broussard and then Dennis White Sr, engineers for the site. We discussed operations and plans for the site. Mr. Broussard said that they were excavating the east flank of the shooting range berm while awaiting metals testing for the rest of the berm. Mr. White said that they had just gotten the results back, and while the tests came back below regulatory levels, they plan to excavate the first three feet thickness of the remaining berm and dispose of it at an MSW landfill out of an abundance of caution. The remaining dirt will be used onsite. I told him I had no objection to that plan.

Photo 13-Middle section of the site has been cleared but was not currently being worked.

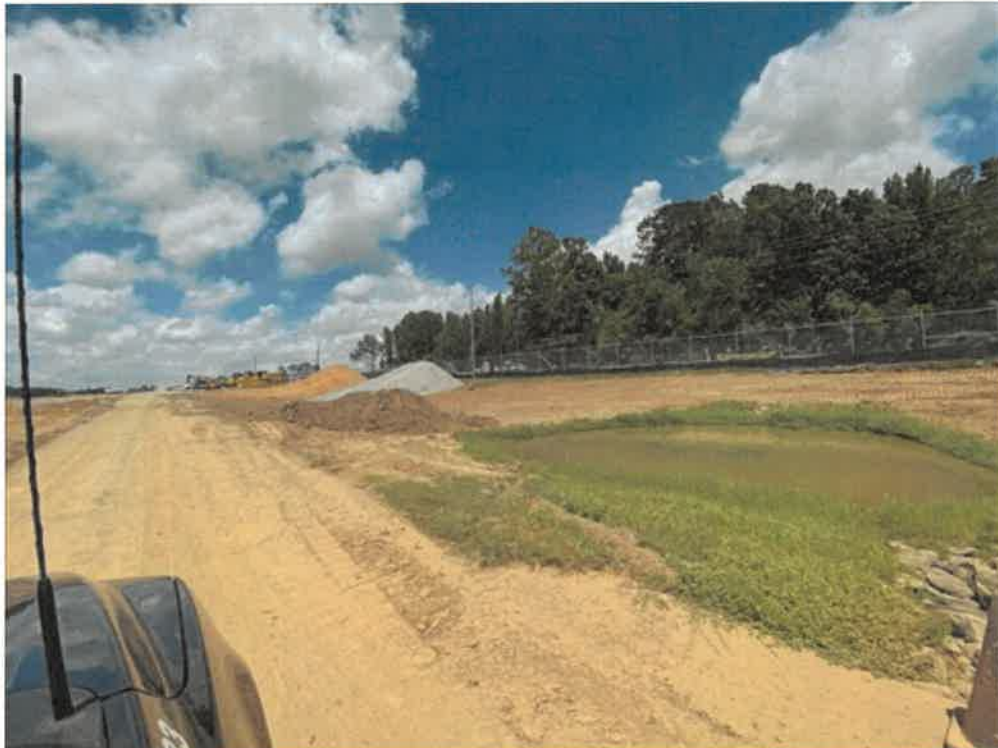
Photo 14-Material stockpiled along east fence with no controls.

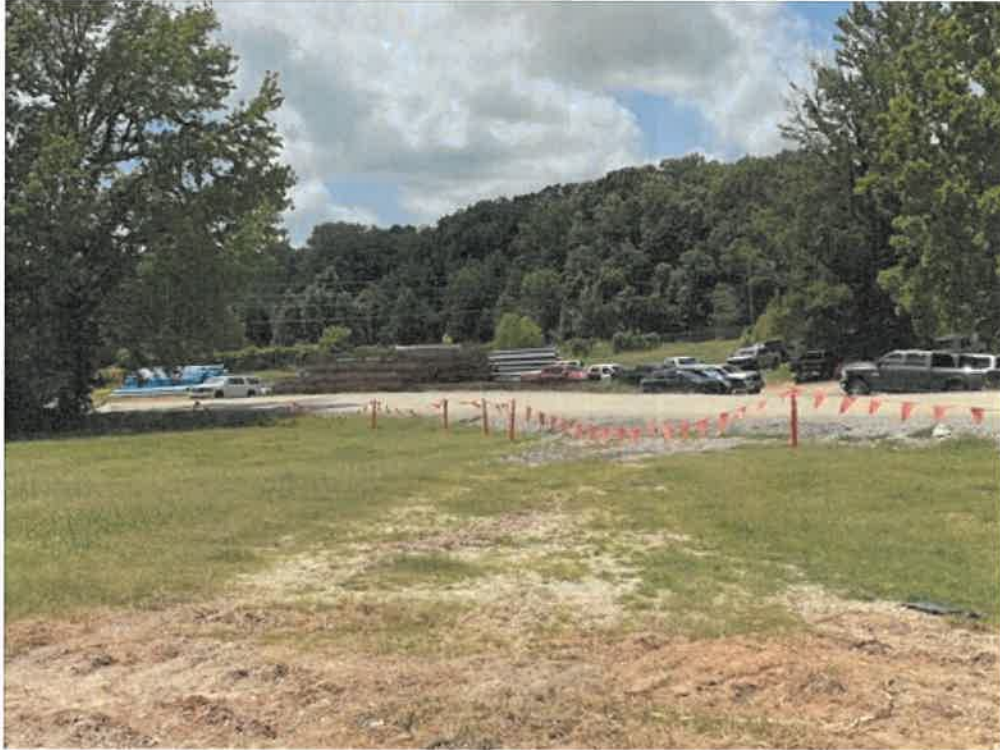
The far west portion of the site is currently being used as a parking/storage/laydown area for Omega Foundation Services from Slaughter, LA. They have added gravel over a large area for the laydown/equipment parking space needed, but no earthmoving activities were observed in this area (Photos 15-18). I do not know if they removed any vegetation before laying down the gravel. The non-graveled parts have good vegetative cover established. We did not collect GPS data for this area.

Photo 15-Looking west into Omega Foundation Services parking area.

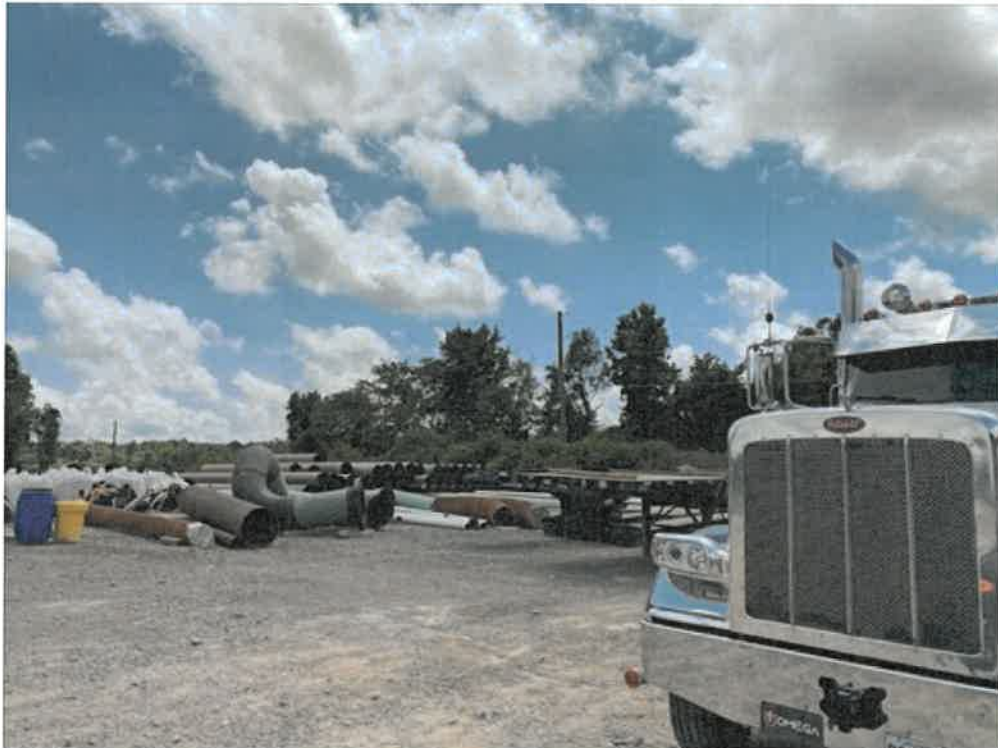
Photo 16-View of stockpiled material at the Omega site.

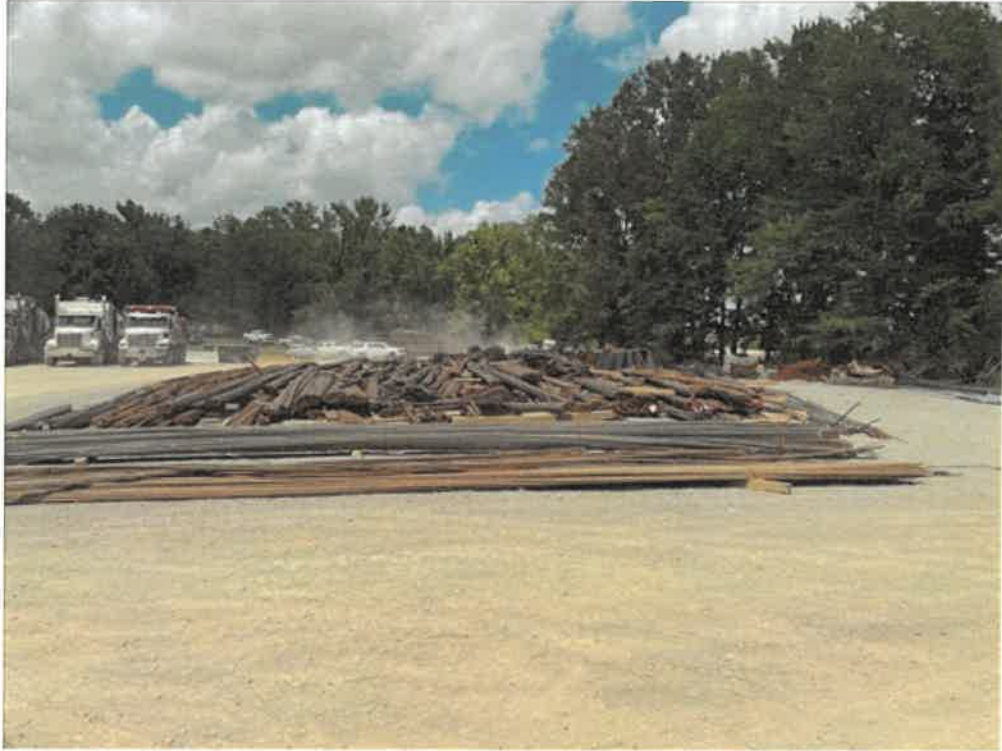
Photo 17-Rebar staging area at Omega lot.

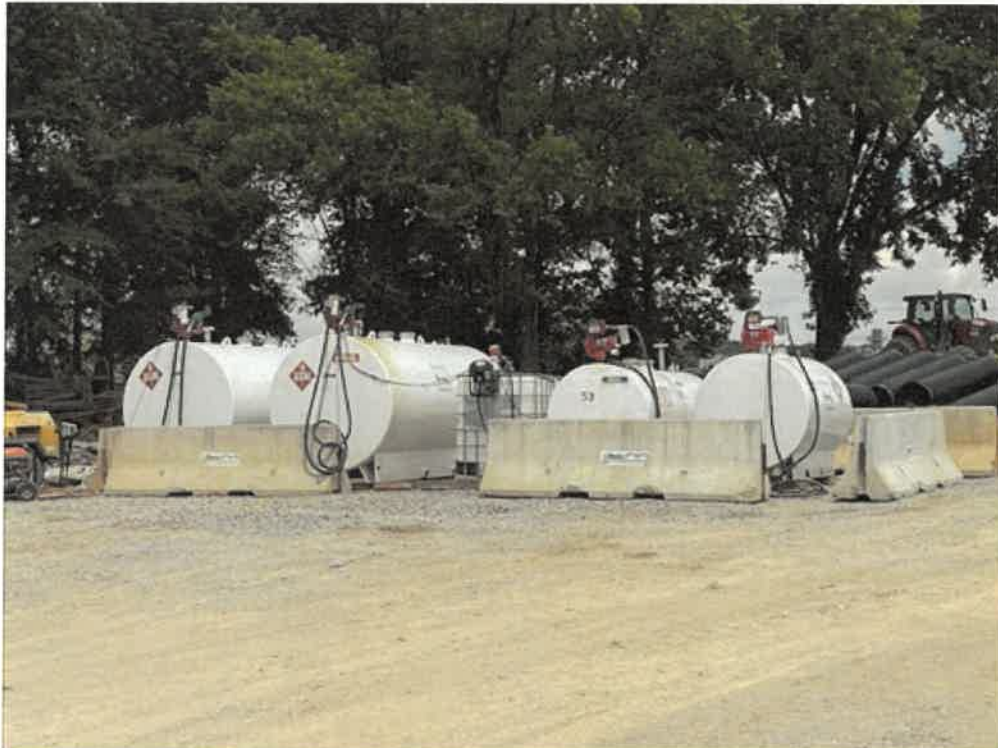
Photo 18-Omega fueling area.
